# LASER®

## GEN 2 Wheel Bearing Kit VAG | 85mm

## Instructions

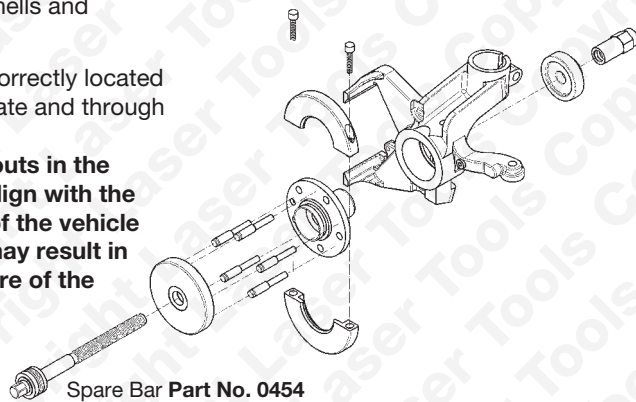
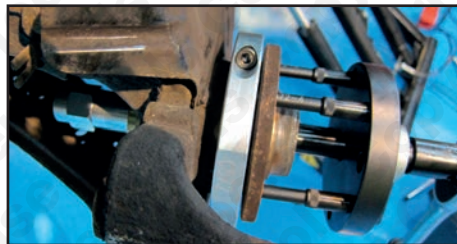
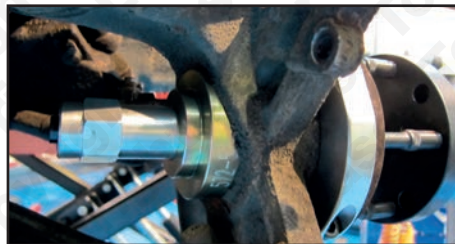
## Instructions | Fitting

- Use **Silver | Black** clamshells and puller bush for fitting.
- Ensure the load pins are correctly located in the holes in the force plate and through the drive flange.

**NB. Ensure machined cut outs in the insertion clam shells align with the raised casting marks of the vehicle hub. Failure to do so may result in misalignment and failure of the force screw.**

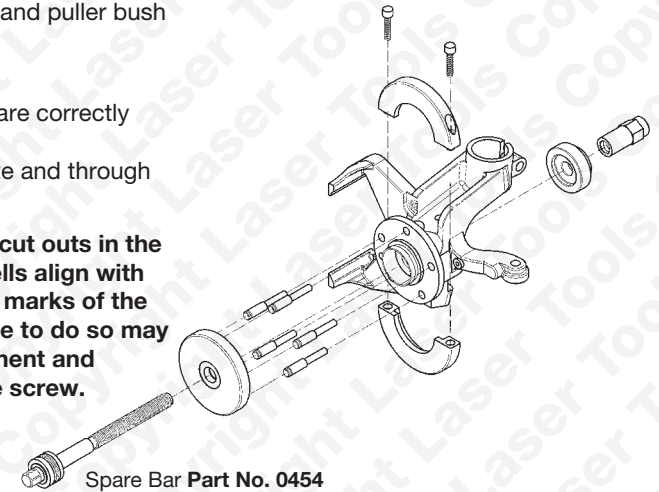
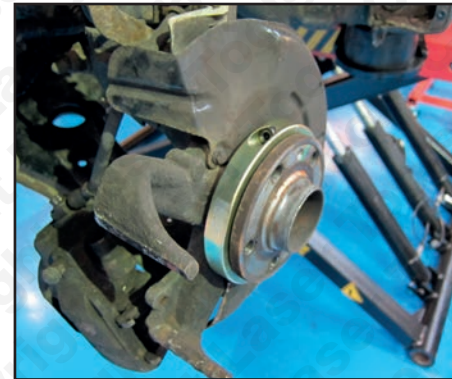
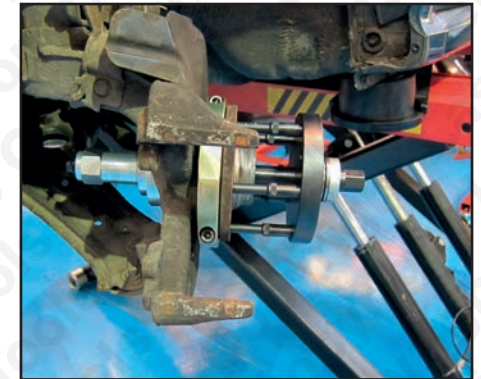
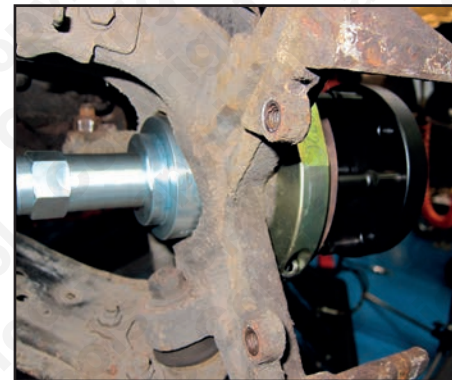
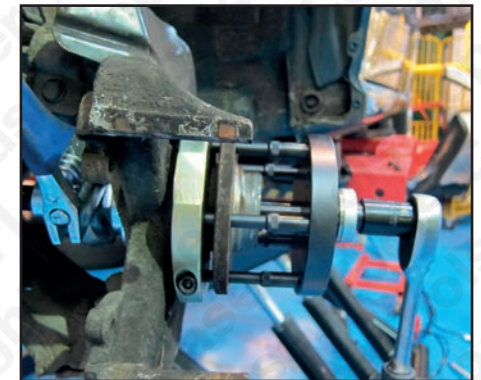
## Instructions | Removal

- Use **Gold** clamshells and puller bush for bearing removal.
- Ensure the load pins are correctly located in the holes in the force plate and through the drive flange.

**NB. Ensure machined cut outs in the insertion clam shells align with the raised casting marks of the vehicle hub. Failure to do so may result in misalignment and failure of the force screw.**
