Rear Hub Nut Tool - LDV/MAXUS V90 & Deliver 9

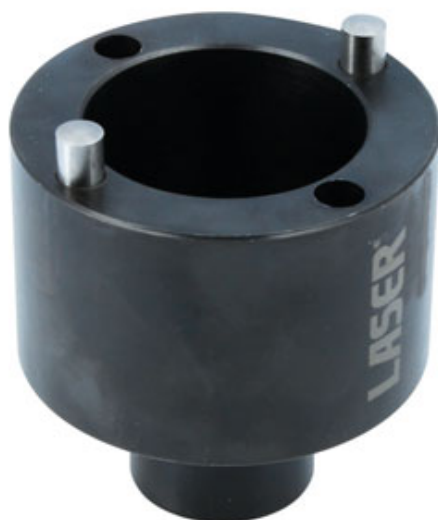
The rear hub nut found on the post-2019 MAXUS V90 & Deliver 9 light commercial vehicles utilise a 2-pin hub nut that is tightened to over 500Nm. It is necessary to remove this nut to service the rear brake disc, handbrake shoes and half shafts. The Laser 9187 has been designed to allow the user to remove the fixing without damage.

- Applications include: MAXUS V90 & Deliver 9 (from 2019).
- Hub nut/lock nut, 2-pin socket.
- 3/4"D. Outside diameter: 88mm.
- Manufactured from carbon steel for strength. Due to the high tightening torque required Laser Tools recommends the use of a torque multiplier such as Laser Part No. 7318 or similar.
- NOTE: Due to the nature of the 2-pin fixing this socket is not to be used with impact tools.
